X-ray irons out electronic flaws at Process Sciences Inc.

XT V @ Process Sciences Inc. (USA)

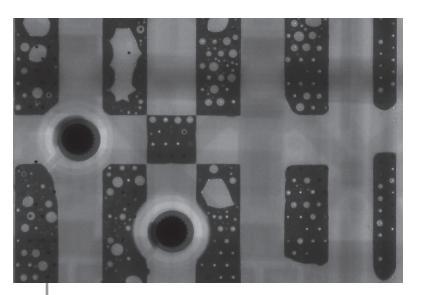
On magnified x-ray images, voids and other defects in metallic surfaces immediately attract the attention

Schoppe explains that image resolution up to 1 micron provides great insight into internal defects, such as inclusions found in solid metallic material. "In solid-state switches, for example, X-ray helped us identify irregularities inside the welded parts of the components. Similarly, we traced internal cracks in ceramic chip capacitors that were caused by electric stress."

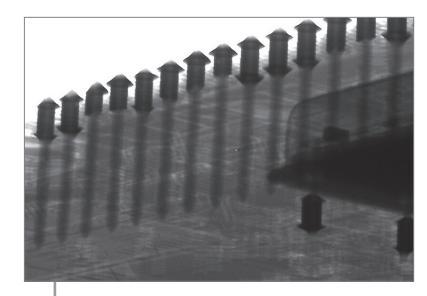
X-ray traces incomplete vias and helps create alternative routes for these open connections

Also incomplete vias are typically hard to trace without X-ray. "We use the system's qualitative imaging and real-time X-ray capabilities to intuitively navigate through the layers of a PCB, by changing position, angle and zoom as desired. When detecting an open caused by an incomplete via, we investigate the surrounding internal structure to create an alternative route for the failing connection."

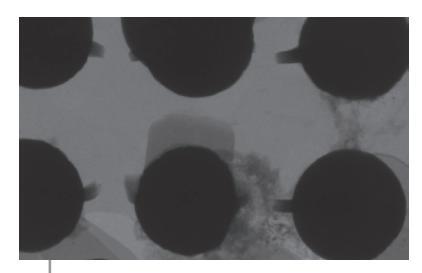
PSI engineers trace minuscule solder dendrites and voids scattered around the solder balls of BGA devices

The XT V system enables us to literally look inside specimens, so that we can trace tricky defects that would otherwise remain buried under chip packages and PCB layers. Using angled imaging with high magnification, we reveal mysterious shorts in the form of minuscule solder dendrites and voids scattered around ball grid array (BGA) connections. In this case, we desolder, reball and reflow the device to reestablish correct and robust electronic connections.

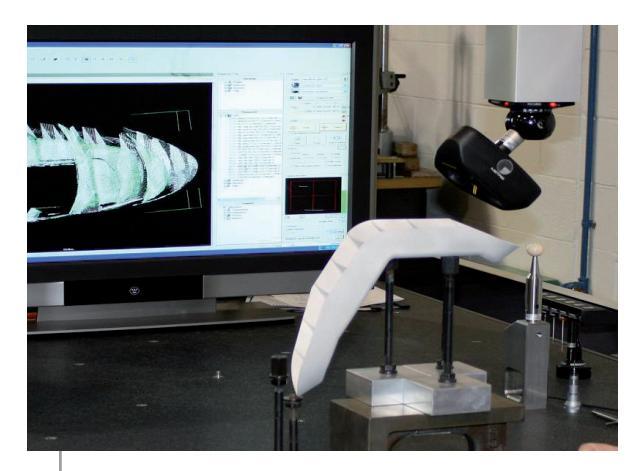
Nikon Metrology's Cross Scanner acquired the entire geometry of the wing tip light housing.

PolyWorks software's IMAlign[™] module was used to align partial scans, verify surface coverage and remove scan overlap data in creating a single set of data points. Next, the aligned scans were merged using the IMMerge[™] module to create a highly accurate finely detailed polygonal mesh model of the digitized parts.

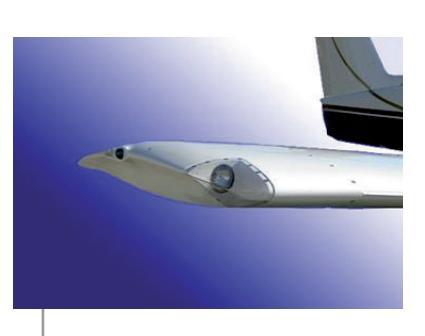
Example of an integrated wing tip light

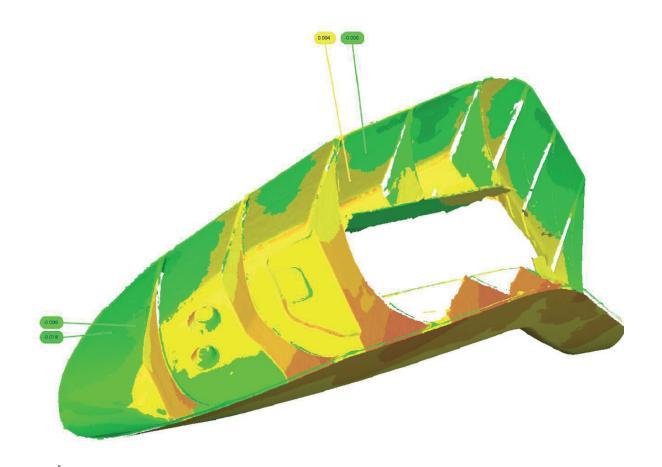
A color map showing the global comparison between the digitized points and their CAD reference.

The polygonal mesh model was then exported to PolyWorks IMInspect[™] module for the actual dimensional inspection process. For this specific project, a global comparison was performed by calculating the deviation between each digitized point and its corresponding CAD reference. A color map was displayed according to the tolerances set by O'Fallon Casting. O'Fallon Casting engineers measured the clearance of the part by comparing 3D distances between two planes to ensure that the ray of light is projected without interference.

"In addition to the data, we include snapshots of the model comparison so that customers can quickly see where the part is out of tolerance," Galmiche said. "We can also illustrate where the part is just a small amount out of tolerance or greatly so by using different colors to indicate different tolerance ranges. Finally, thanks to the PolyWorks IMView free viewer software, our customers can visualize their inspection projects in 3D from their own workstations."

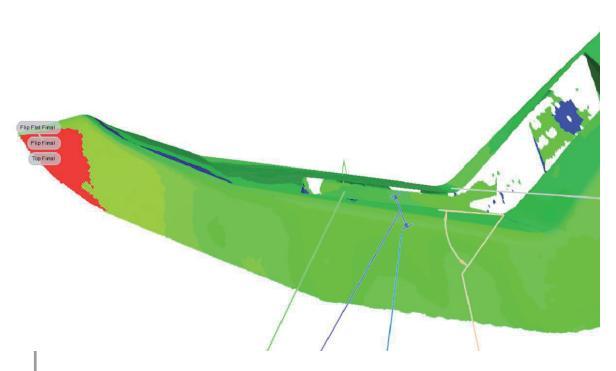
Wall thickness, clearance, 3D angle and flatness analyses are performed using PolyWorks IMInspect
